AUGUST 2020

EVALUATION OF ACTIVE DRIVING ASSISTANCE SYSTEMS

NewsRoom.AAA.com

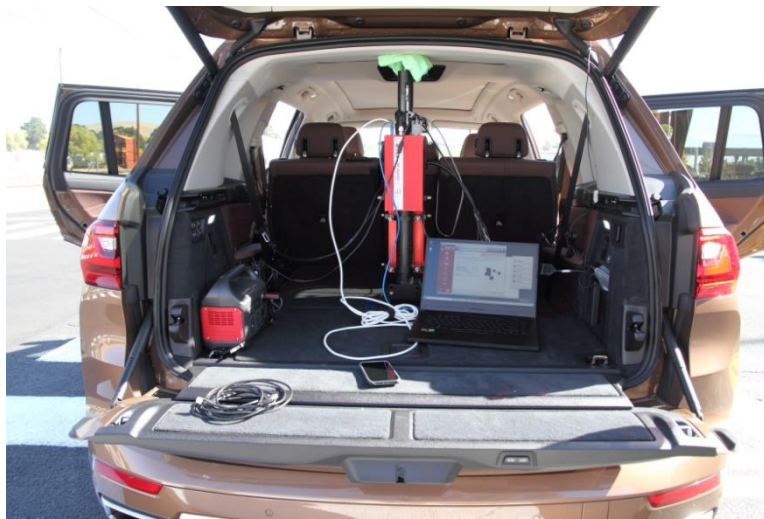
Figure 2: Test vehicle outfitted with closed-course instrumentation Image Source: AAA

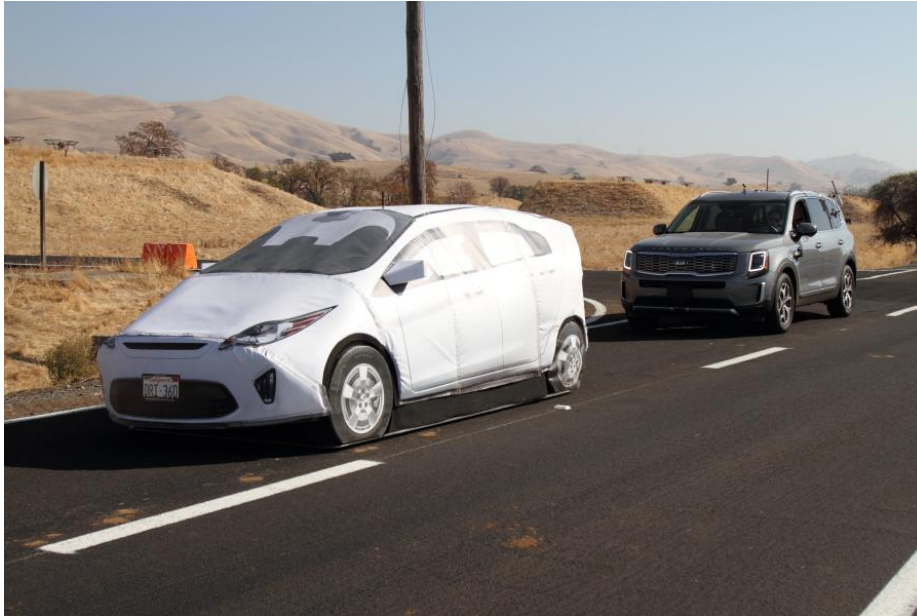
Figure 8: DRI Low Profile Robotic Vehicle Image Source: AAA

The Soft Car 360® is calibrated to be representative of a small passenger vehicle relevant to automotive sensors including radar and cameras. The hatchback model was utilized for testing; its length, width and height are 158 in, 67 in and 56 in, respectively.

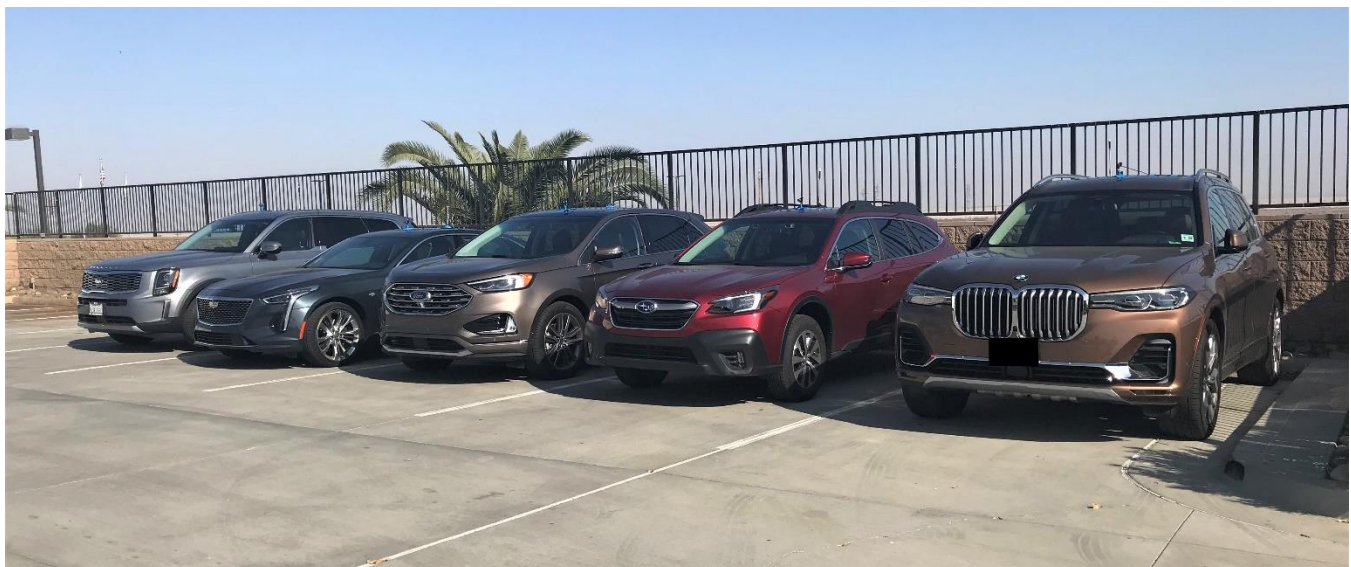
Figure 9: Test vehicles outfitted with naturalistic instrumentation Image Source: AAA

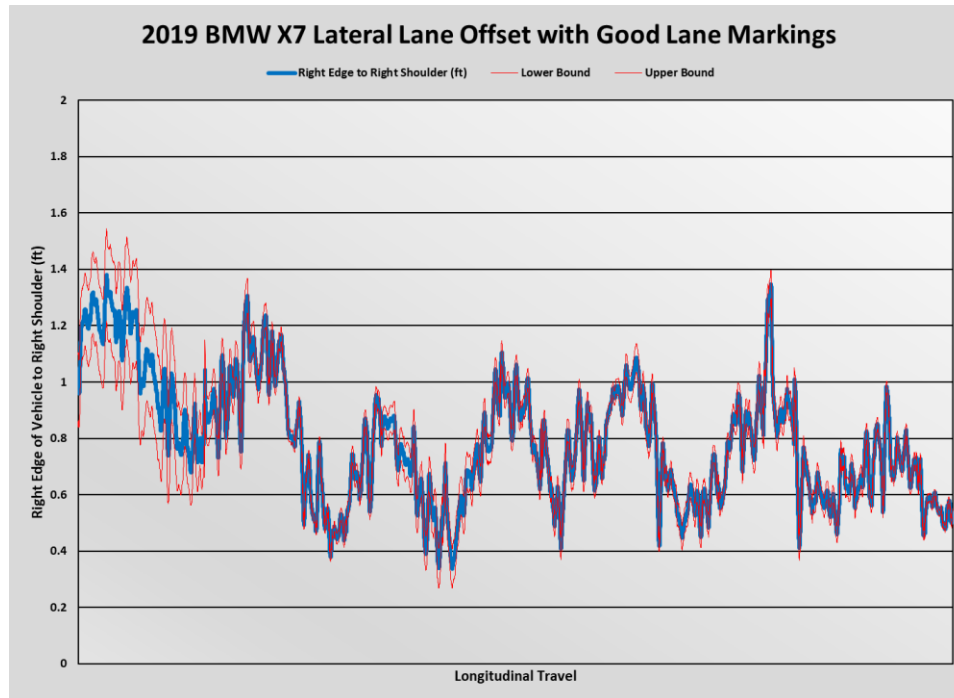
Figure 11: Average lateral lane offset with good lane markings Image Source: AAA

Figure 11 illustrates the lateral placement of the vehicle throughout the entirety of the testing lane. When traversing the roadway, the average lateral offset from the right shoulder was maintained between roughly 0.35 ft to 1.35 ft throughout the entirety of the testing lane. This implies acquisition of lane markings by the system; however, some variation with respect to lateral placement within the test lane was noted. The standard error calculated from all test runs is largely insignificant; this signifies consistent lane positioning from run to run for the evaluated roadway.

The vehicle remained slightly offset towards the right side of the testing lane throughout the entirety of the test. This observation does not imply negative performance as the vehicle remained within the lane during the entirety of the test.

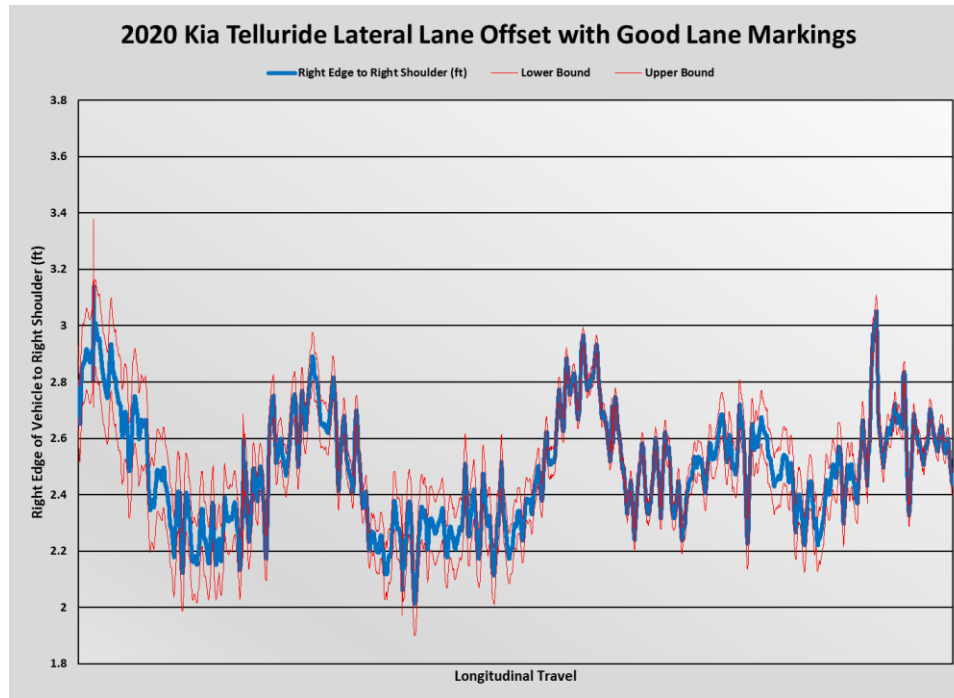
Figure 12: Average lateral lane offset with good lane markings Image Source: AAA

Figure 12 illustrates the lateral placement of the vehicle throughout the entirety of the testing lane. When traversing the roadway, the average lateral offset from the right shoulder was maintained between roughly 2.00 ft to 3.10 ft throughout the entirety of the testing lane. This implies acquisition of lane markings by the system; however, some variation with respect to lateral placement within the test lane was noted. The standard error calculated from all test runs is largely insignificant; this signifies consistent lane positioning from run to run for the evaluated roadway.

Within some areas along the roadway, the vehicle was somewhat offset towards the left side of the testing lane. This observation does not imply negative performance as the vehicle remained within the lane during the entirety of the test. However, this finding should be noted especially in the context of two-lane highways that are undivided from oncoming traffic.

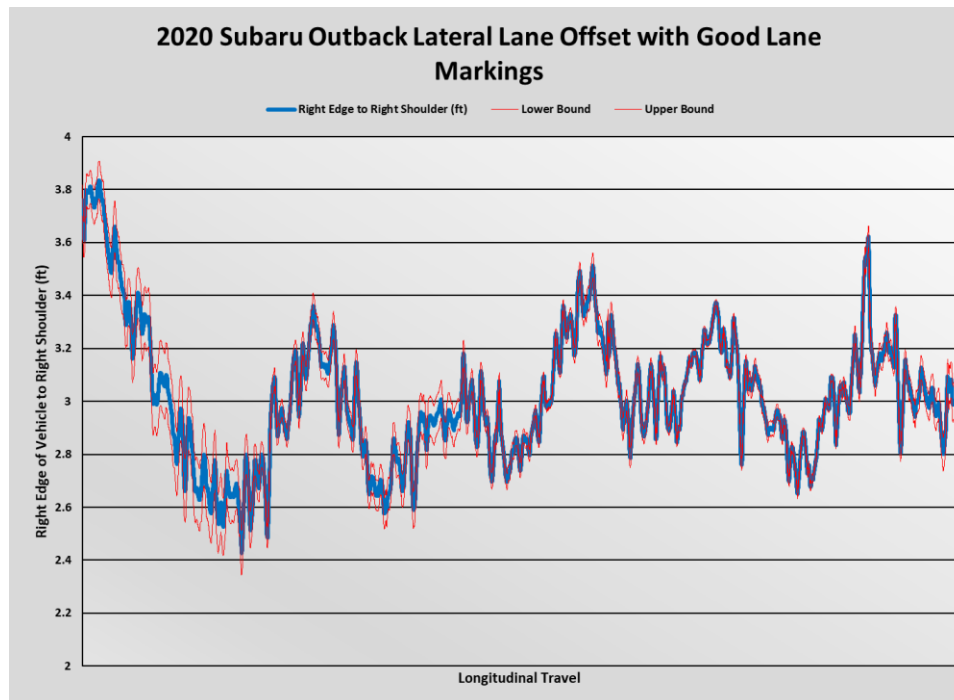
Figure 13: Average lateral lane offset with good lane markings Image Source: AAA

Figure 13 illustrates the lateral placement of the vehicle throughout the entirety of the testing lane. When traversing the roadway, the average lateral offset from the right shoulder was maintained between roughly 2.50 ft to 3.80 ft throughout the entirety of the testing lane. This implies acquisition of lane markings by the system; however, some variation with respect to lateral placement within the test lane was noted. The standard error calculated from all test runs is largely insignificant; this signifies consistent lane positioning from run to run for the evaluated roadway.

Within some areas along the roadway, the vehicle was offset towards the left side of the testing lane. This observation does not imply negative performance as the vehicle remained within the lane during the entirety of the test. However, this finding should be noted especially in the context of two-lane highways that are undivided from oncoming traffic.

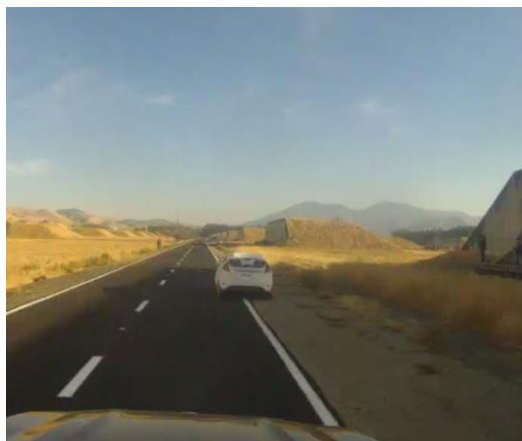
To simulate this situation, the DRI Soft Car 360® (herein referred to as the “target vehicle”) was parked approximately halfway off the right side of the testing lane previously described in [Section 4.2](#). In other words, the centerline of the vehicle was approximately located over the solid white line on the lateral side of the testing lane. The lateral placement of the target vehicle could be considered a best-case scenario in terms of detection opportunity with the exception of the target vehicle being placed directly in the center of the testing lane. In many cases when a disabled vehicle is partially within a roadway, it is common for only a small portion of the vehicle to obstruct the travel lane. A typical example would be a vehicle parked diagonally relative to the roadway with only the rear corner of the vehicle in the travel lane.

Figure 14: Lateral placement of DRI Soft Car 360® Image Source: AAA

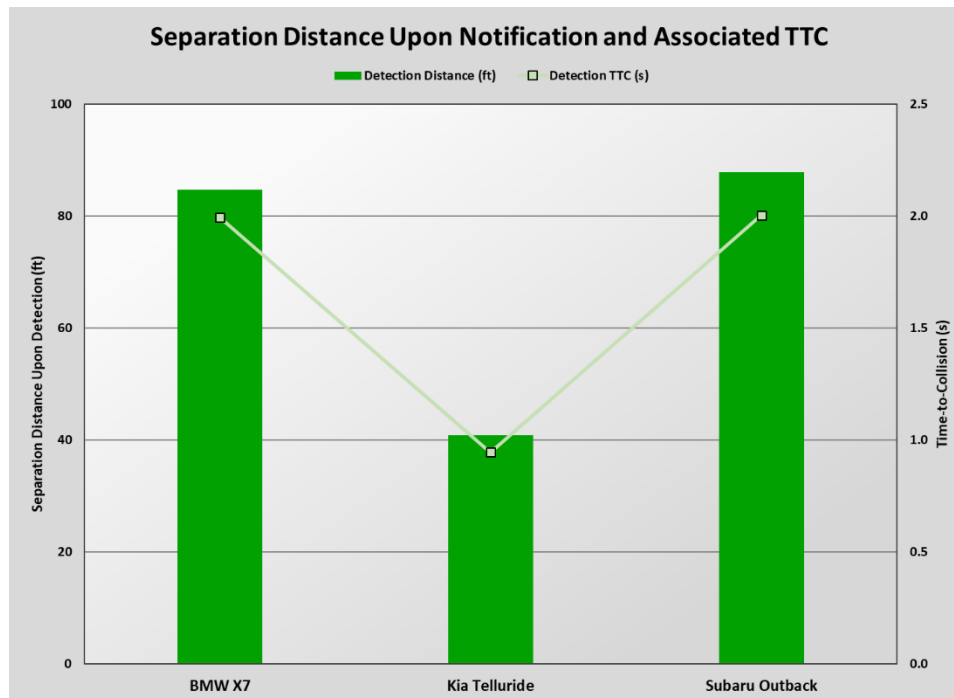
Figure 18: Average test vehicle detection distance and TTC Image Source: AAA

At 20 mph, each test vehicle provided notification of an imminent collision for a combined eight out of nine runs. Two out of three test vehicles completely avoided a collision with the target vehicle for at least one of three runs. However, for all nine test runs conducted in aggregate, a collision occurred 66 percent of the time.

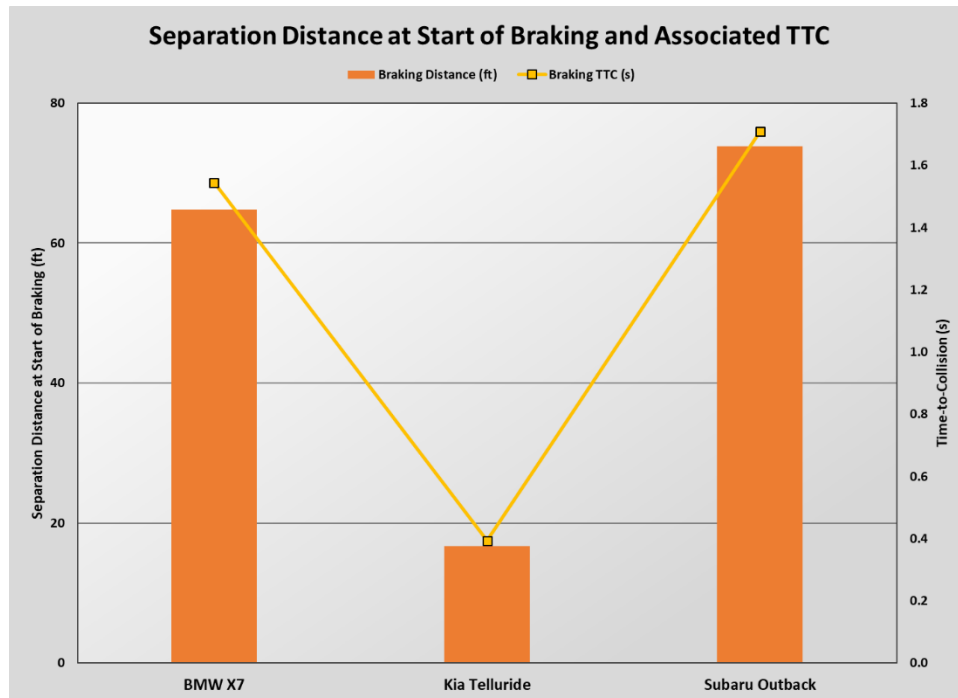
Figure 19: Average test vehicle braking distance and TTC Image Source: AAA

In a majority of cases, notification did not necessarily translate to collision avoidance. Specifically, while collision notification was provided for eight out of nine test runs in aggregate, a collision was avoided for only three out of nine runs. For collisions that occurred, the average impact and mitigation speed was 24.6 mph and 5.4 mph, respectively. It is also important to note for each test vehicle, performance varied significantly between the three test runs. Specifically, each test vehicle demonstrated some degree of inconsistency in terms of both detection and braking distance from run to run. Most importantly, each test vehicle impacted the target vehicle at least once. This illustrates that tested ADA systems cannot be trusted to consistently react to stopped vehicles either within or alongside the roadway. As such, drivers must maintain awareness of their surroundings and control of the vehicle at all times.

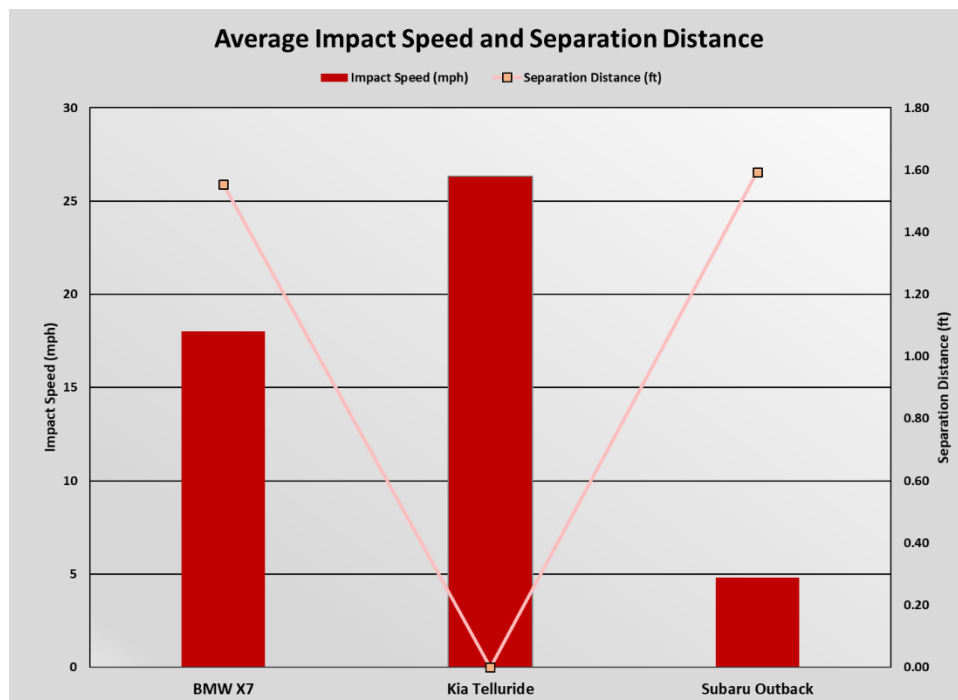
Figure 20: Average test vehicle impact speed and separation distance Image Source: AAA

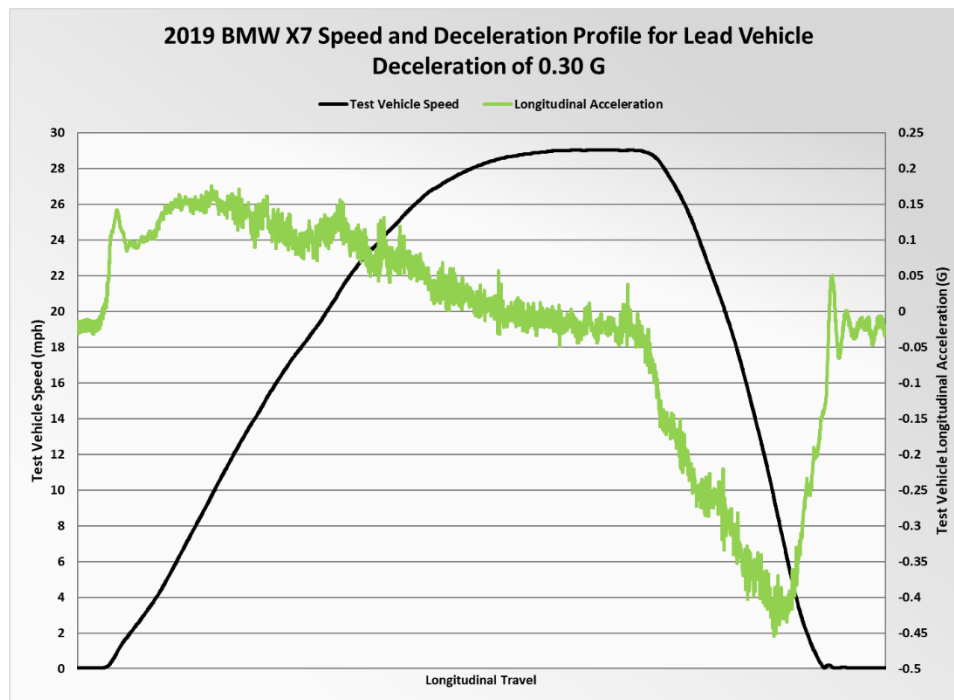
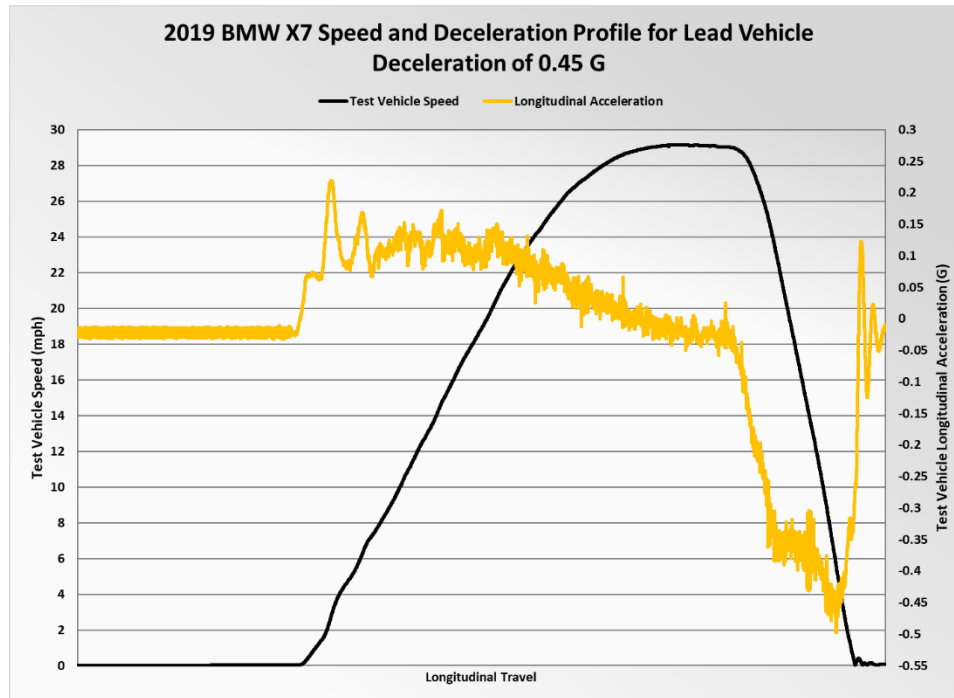
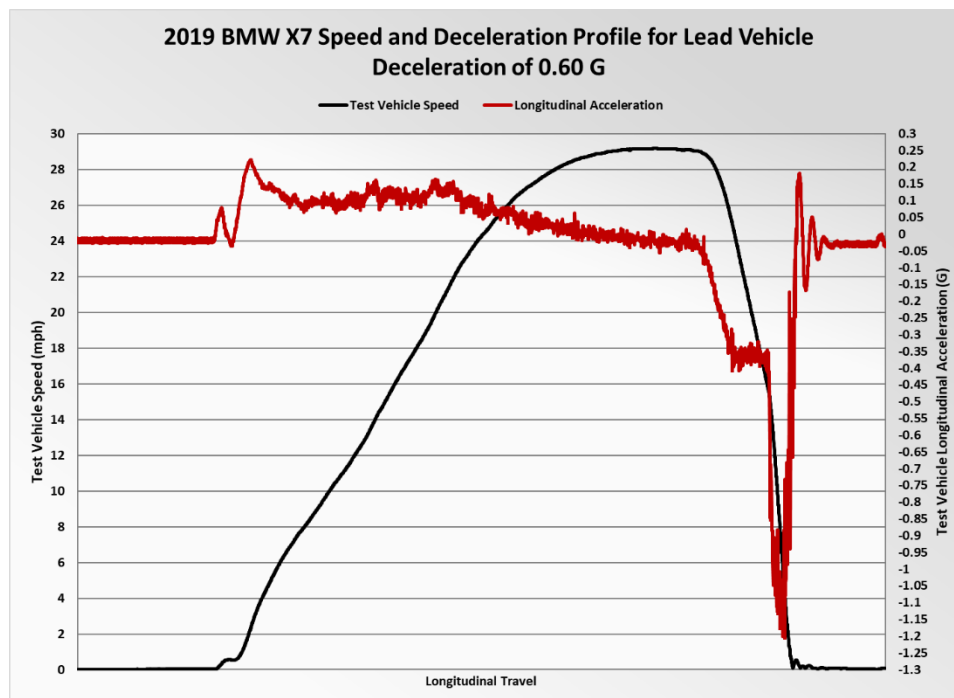
Figure 22: 2019 BMW X7 characteristic deceleration profile (0.30 G lead vehicle deceleration) Image Source: AAA

Figure 23: 2019 BMW X7 characteristic deceleration profile (0.45 G lead vehicle deceleration) Image Source: AAA

Figure 24: 2019 BMW X7 characteristic deceleration profile (0.60 G lead vehicle deceleration) Image Source: AAA

Figures 22-24 illustrate the deceleration profiles associated with each lead vehicle deceleration rate. At 0.30 G, the system decelerated smoothly as shown by the mostly linear rate of deceleration with a

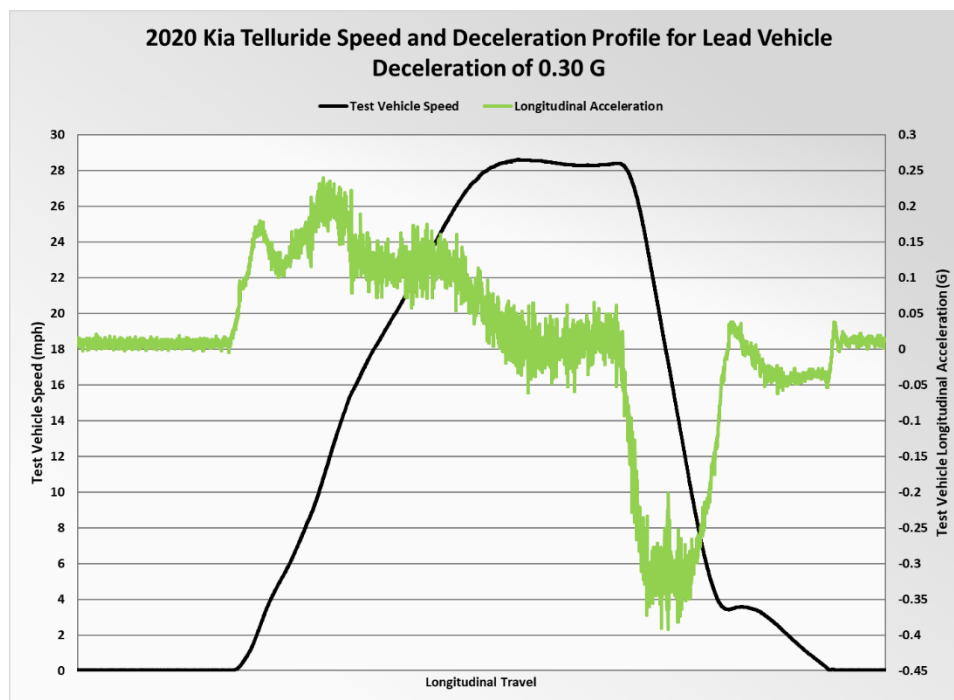
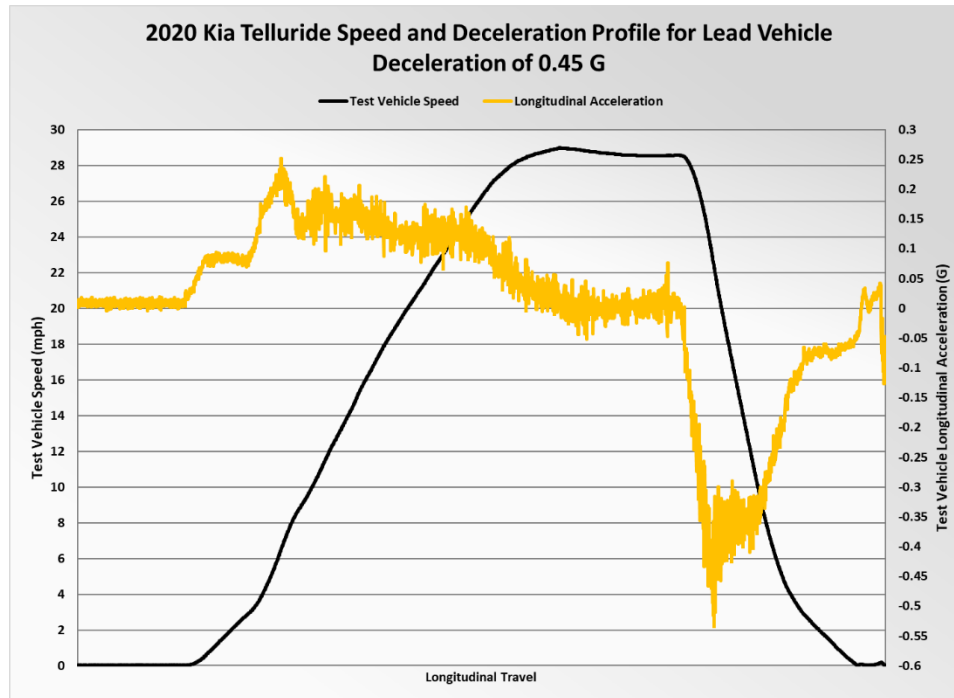
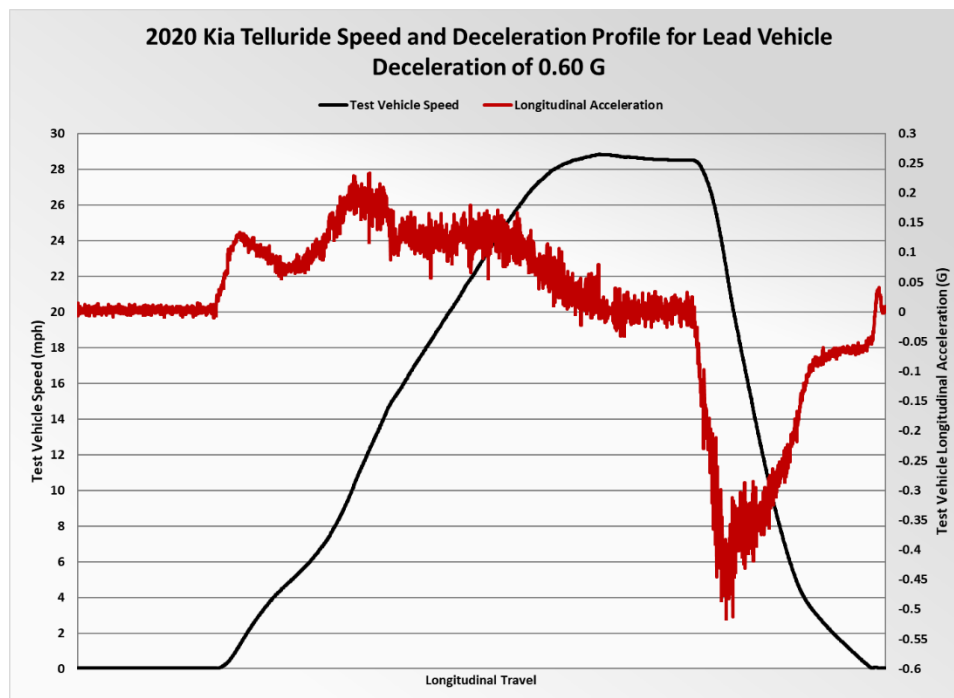
Figure 26: 2020 Kia Telluride characteristic deceleration profile (0.30 G lead vehicle deceleration) Image Source: AAA

Figure 27: 2020 Kia Telluride characteristic deceleration profile (0.45 G lead vehicle deceleration) Image Source: AAA

Figure 28: 2020 Kia Telluride characteristic deceleration profile (0.60 G lead vehicle deceleration) Image Source: AAA

Figures 26-28 illustrate characteristic deceleration profiles associated with each lead vehicle deceleration rate. All deceleration profiles exhibit similar characteristics including a linearly increasing deceleration rate to a plateau between 0.35 G to 0.40 G. After the rate plateaus, the deceleration rate gradually decreases as the vehicle comes to a stop. At 0.30 G, the vehicle crept forward momentarily before coming to a complete stop. Regardless of lead vehicle deceleration rate, stops were noticeably smooth relative to other test vehicles.

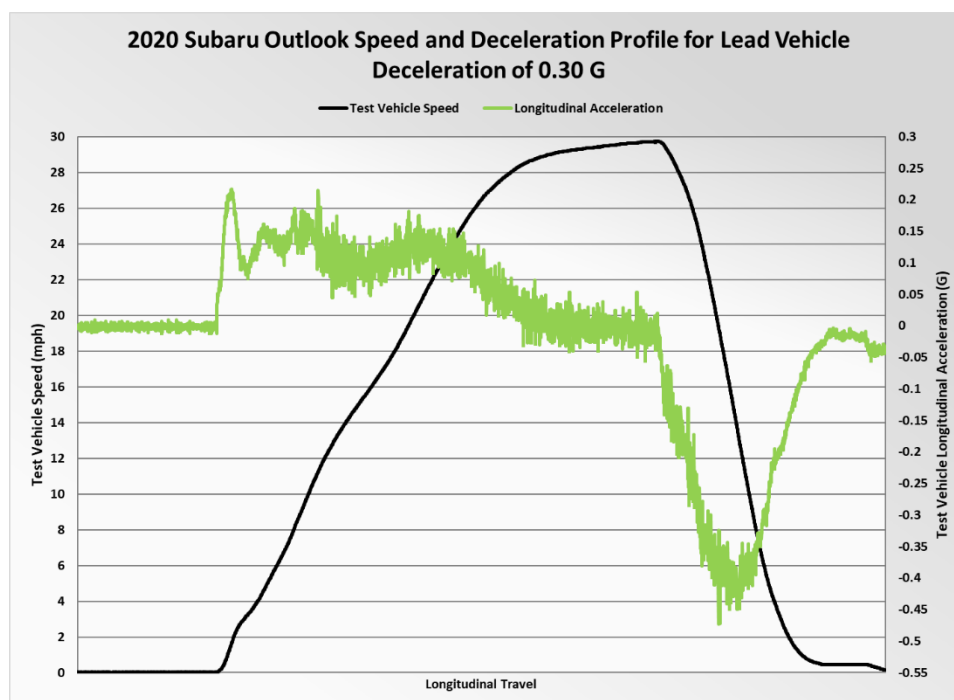
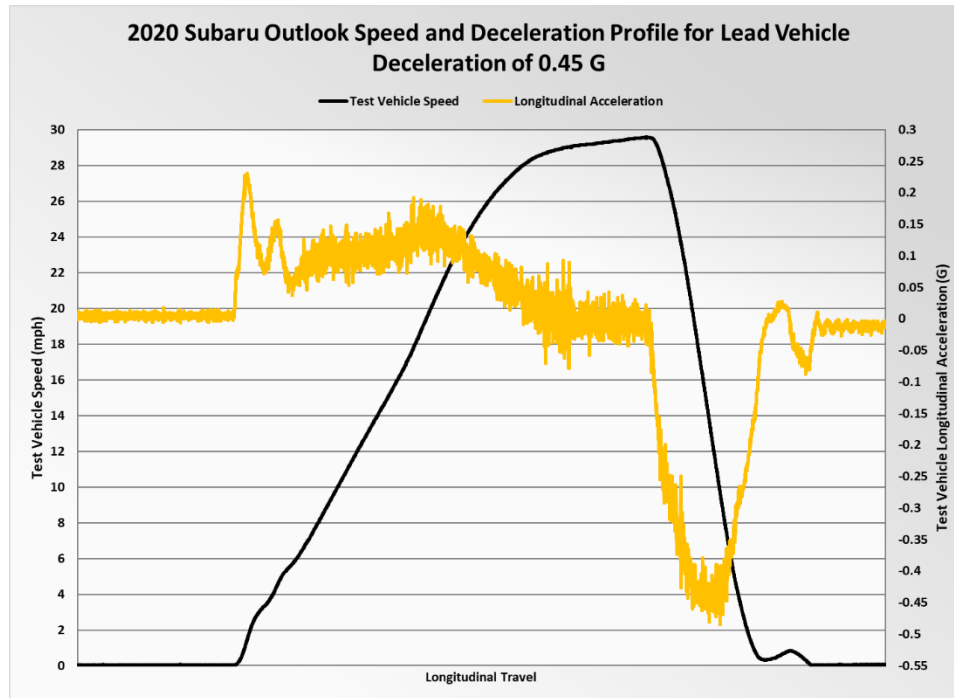
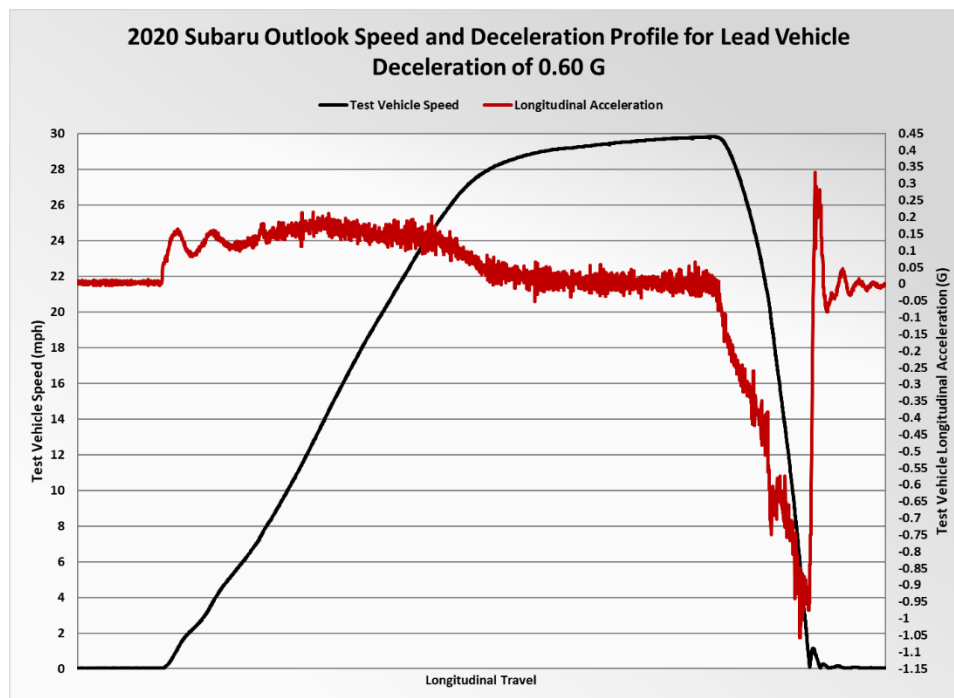
Figure 30: 2020 Subaru Outlook characteristic deceleration profile (0.30 G lead vehicle deceleration) Image Source: AAA

Figure 31: 2020 Subaru Outlook characteristic deceleration profile (0.45 G lead vehicle deceleration) Image Source: AAA

Figure 32: 2020 Subaru Outlook characteristic deceleration profile (0.60 G lead vehicle deceleration) Image Source: AAA

Figures 30-32 illustrate characteristic deceleration profiles associated with each lead vehicle deceleration rate. At 0.30 G and 0.45 G, the system decelerated with a linearly increasing rate and plateaued approximately between 0.40 G to 0.45 G before linearly decreasing until the vehicle was almost stopped. At this point, the vehicle crept forward slightly before coming to a complete stop. At 0.60 G, the system exhibited a multi stepwise deceleration profile with brief plateaus at 0.40 G and 0.65 G before increasing to a maximum at approximately 1.00 G. This maximum rate was maintained until the vehicle came to a stop, resulting in a noticeably abrupt stop.

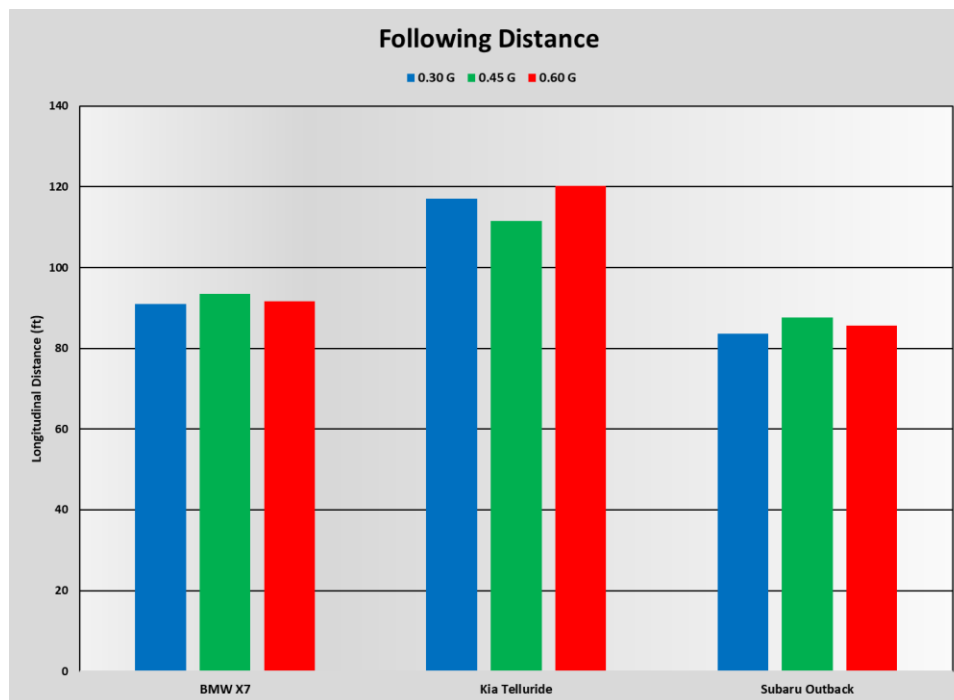
Figure 33: Average test vehicle following distance Image Source: AAA

Figure 33 illustrates for each test vehicle, differences in following distance with respect to lead vehicle deceleration were not significant. This is an expected result; the only parameter that is anticipated to influence following distance is vehicle speed. For all runs, the test vehicle nominal speed was kept constant at 30 mph.

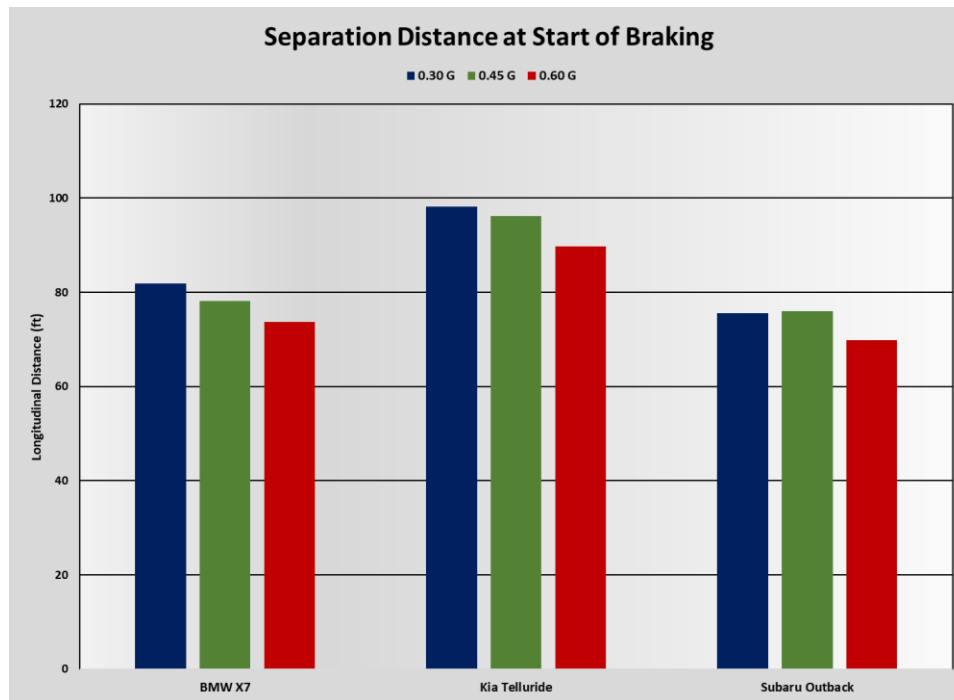
Figure 34: Average separation distance at start of braking Image Source: AAA

For two out of three test vehicles, the average separation distance at the start of braking slightly decreased as the lead vehicle deceleration rate increased. As a result of decreased separation distance

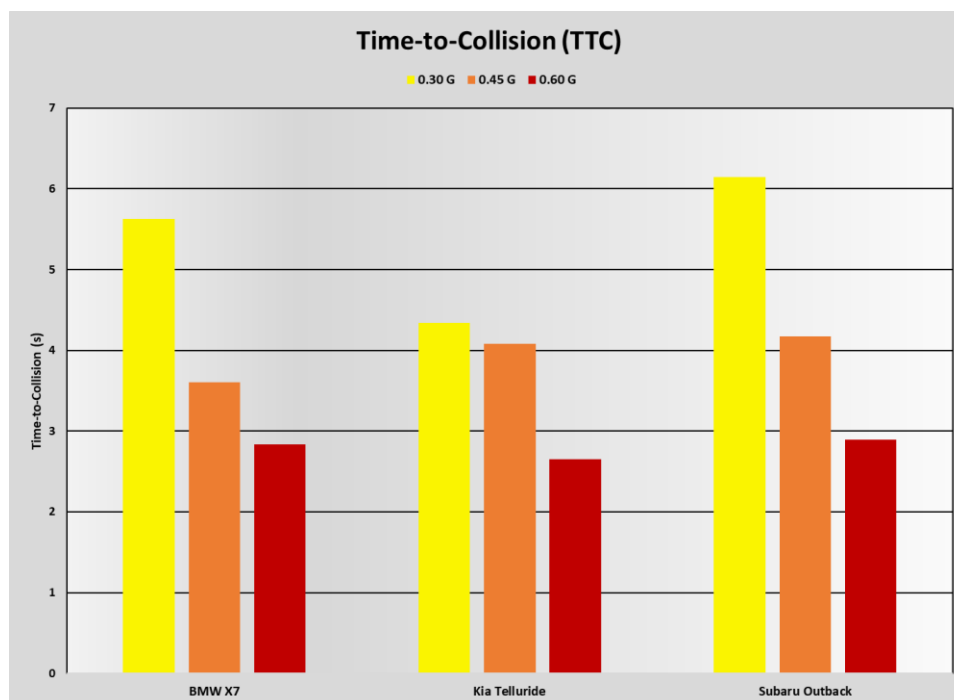
Figure 35: Average test vehicle TTC at start of braking Image Source: AAA

and increased lead vehicle deceleration, the time-to-collision consequently decreased as the lead vehicle deceleration rate increased.

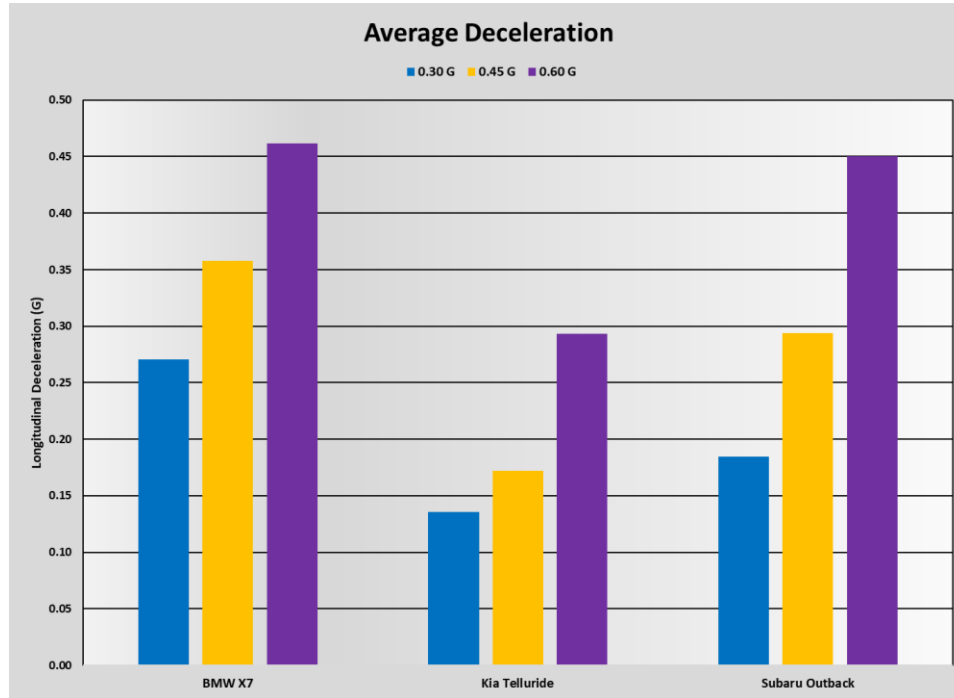
Figure 36: Average test vehicle deceleration Image Source: AAA

For each test vehicle, the average deceleration rate increased as the lead vehicle deceleration rate increased as shown in Figure 36. Additionally, the maximum instantaneous deceleration increased along with lead vehicle deceleration as shown in Figure 37. Two out of three test vehicles exhibited instantaneous maximum decelerations exceeding 1.0 G. This illustrates evaluated systems are capable of applying significant braking input in response to lead vehicle deceleration. However, abrupt stops with high deceleration rates may introduce the possibility of rear-end collisions because following vehicles will have limited time to react.

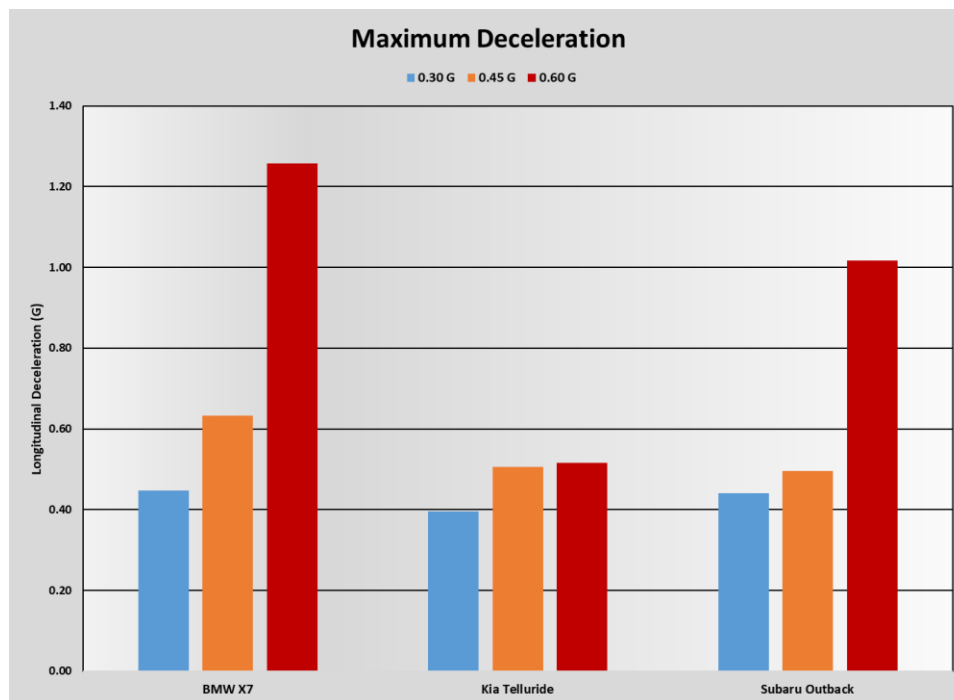
Figure 37: Averaged maximum instantaneous test vehicle deceleration Image Source: AAA

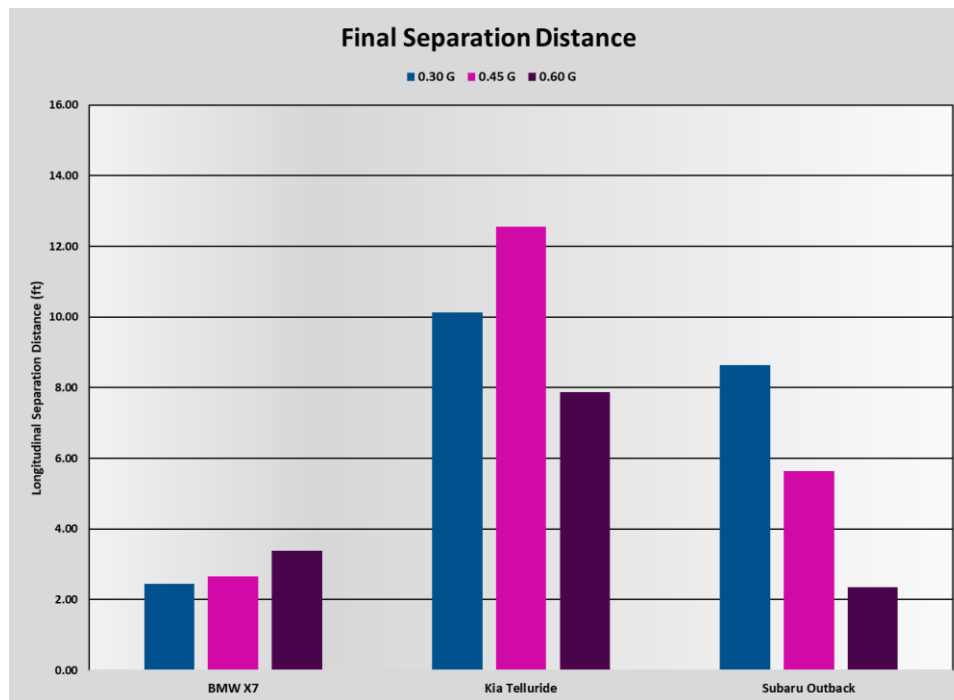
Figure 38: Average test vehicle/lead vehicle separation distance Image Source: AAA

The final separation distance did not vary consistently among test vehicles with respect to lead vehicle deceleration rate as shown in Figure 38. Specifically, the final separation distance slightly increased with increasing lead vehicle deceleration for the BMW X7 whereas the opposite is true for the Subaru Outback. However, the most significant finding is all test vehicles avoided contact with the lead vehicle for all test runs conducted regardless of tested lead vehicle deceleration rate.

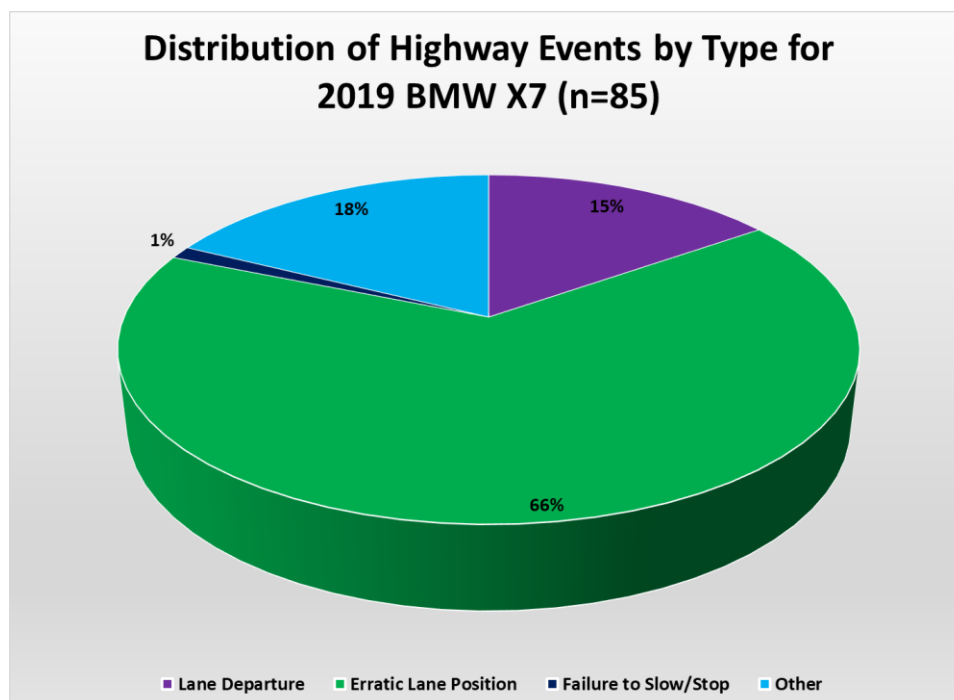
Figure 40: Percent distribution of events by type for the 2019 BMW X7 Image Source: AAA

Figures 39 and 40 illustrate the total number and distribution of each event type observed during naturalistic evaluation. In total, approximately 800 miles were traversed; this translates into roughly one event every 9 miles for the roadways traveled.

Sixty-six percent of events were classified as erratic lane positioning and an additional 15 percent of events were classified as lane departures. In total, 81 percent of noted events pertained to the lane keeping functionality of the BMW's Active Driving Assistant Professional system. Despite this finding, some test drivers noted good general performance in slight and moderate curves. Most test drivers also felt the system performed well during periods of light highway traffic and stop-and-go traffic.

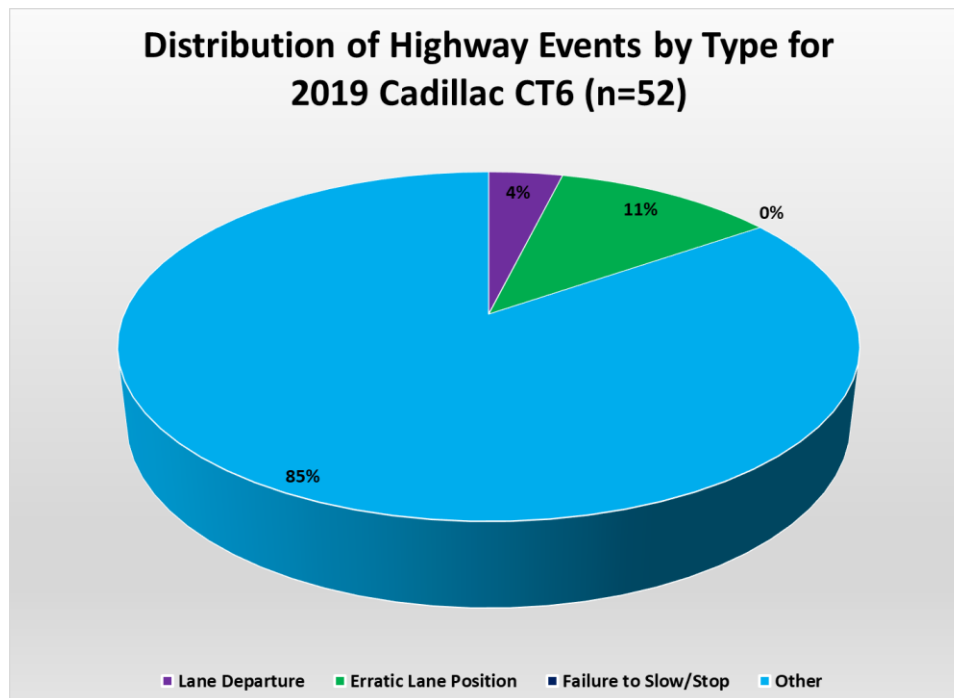
Figure 43: Percent distribution of events by type for the 2019 Cadillac CT6 Image Source: AAA

Figures 42 and 43 illustrate the total number and distribution of each event type observed during naturalistic evaluation. In total, approximately 800 miles were traversed; this translates into roughly one event every 15 miles for the roadways traveled.

Eighty-five percent of events were classified as “other”; 37 out of 44 of these events were either unexpected or erroneous system disengagements. Some disengagements occurred at critical times such as in the middle of a curve with rapidly slowing traffic ahead. While it was easily apparent disengagement occurred, test drivers were sometimes taken by surprise and were required to retake full control in the middle of critical situations with little to no advance notice. Additionally, a significant number of disengagements were noted during which driver inattention was incorrectly detected. This occurred with enough frequency to noticeably detract from the driving experience.

interstates with the system engaged. To maintain consistency in terms of event counting relative to other test vehicles, events noted during this evaluation were not included in Figures 42 and 43.

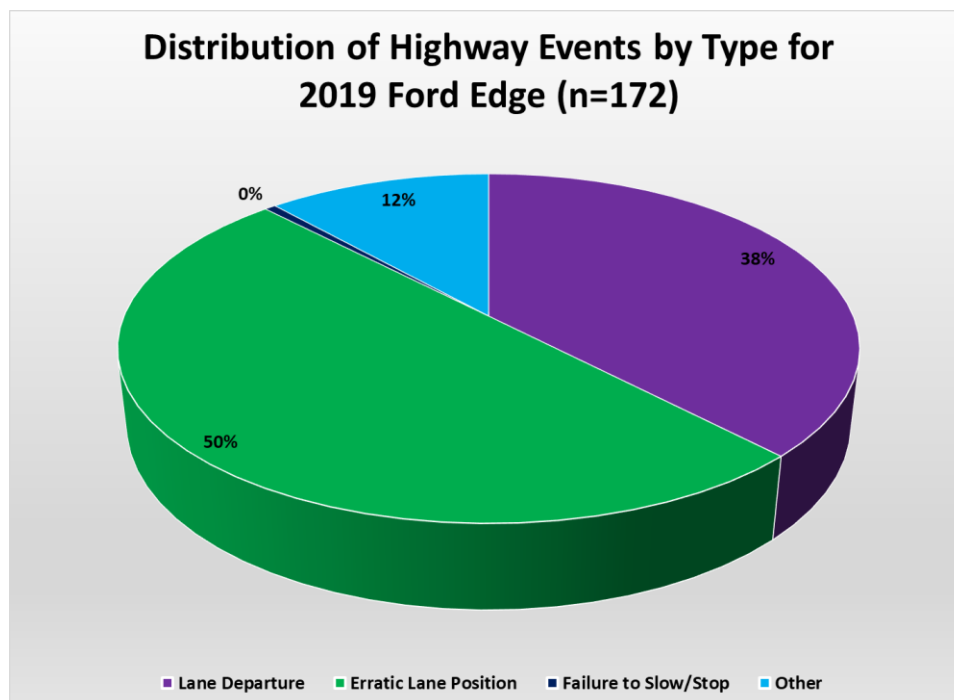
Figure 46: Percent distribution of events by type for the 2019 Ford Edge Image Source: AAA

Figures 45 and 46 illustrate the total number and distribution of each event type observed during naturalistic evaluation. In total, approximately 800 miles were traversed; this translates into roughly one event every 5 miles for the roadways traveled.

Fifty percent of events were classified as erratic lane positioning and an additional 38 percent of events were classified as lane departures. In total, 88 percent of noted events pertained to the lane keeping functionality of the Ford Co-Pilot 360™ system. Both the percent distribution of lane keeping related events and the frequency of occurrence relative to other test vehicles caused general distrust of the system by all test drivers. As a result, the majority of test drivers felt the lane keeping functionality did not enhance the driving experience in most environments; in some cases, test drivers felt the functionality was instead a detriment.

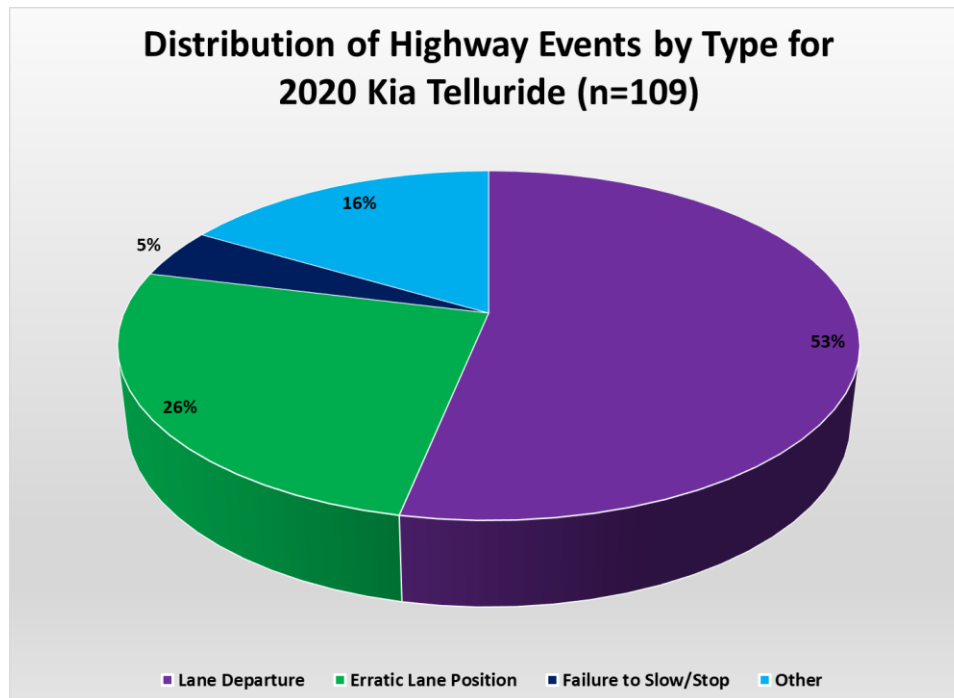
Figure 49: Percent distribution of events by type for the 2020 Kia Telluride Image Source: AAA

Figures 48 and 49 illustrate the total number and distribution of each event type observed during naturalistic evaluation. In total, approximately 800 miles were traversed; this translates into roughly one event every 7 miles for the roadways traveled.
