AUGUST 2020

EVALUATION OF ACTIVE DRIVING ASSISTANCE SYSTEMS

NewsRoom.AAA.com

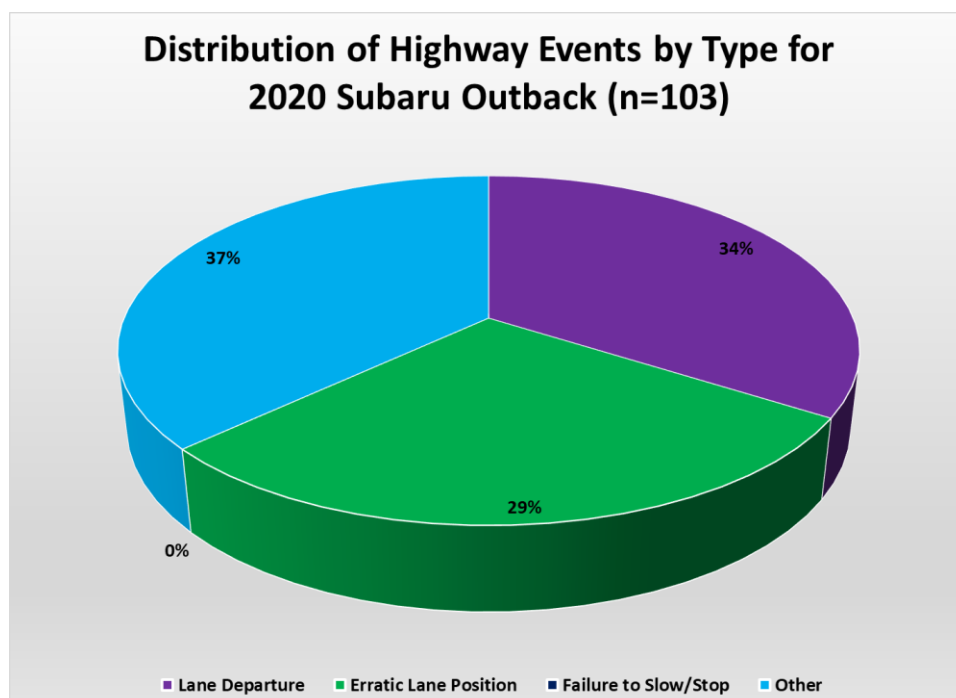
Figure 52: Percent distribution of events by type for the 2020 Subaru Outback Image Source: AAA

Figures 51 and 52 illustrate the total number and distribution of each event type observed during naturalistic evaluation. In total, approximately 800 miles were traversed; this translates into roughly one event every 8 miles for the roadways traveled.

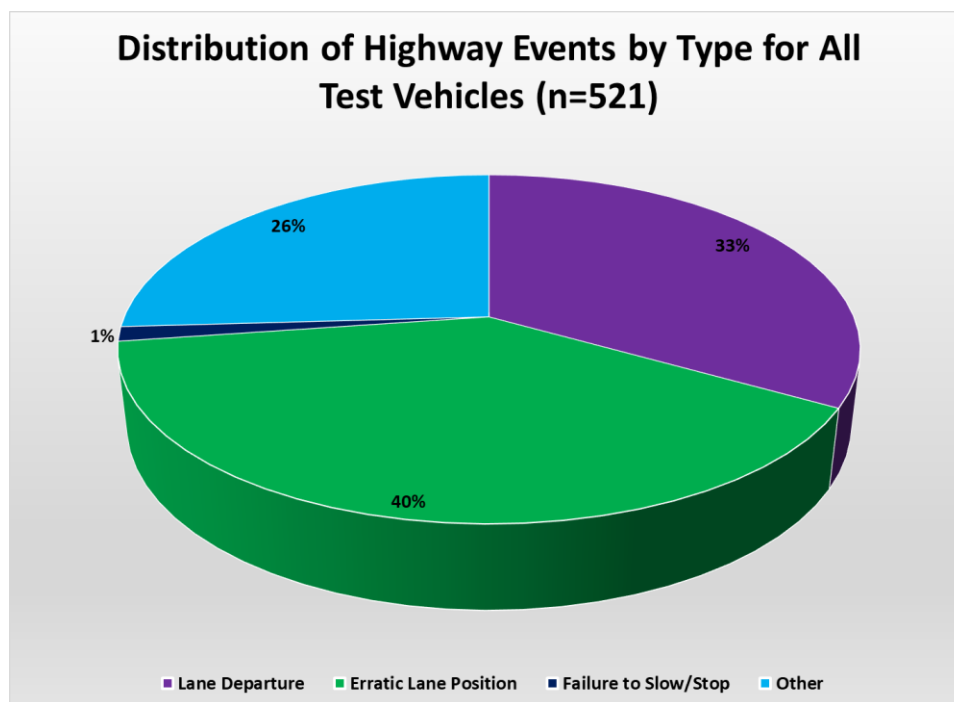
Figure 55: Percent distribution of events by type for all test vehicles Image Source: AAA

Based on findings from earlier work, naturalistic evaluations exclusively focused on the highway environment. In general, all test drivers noted the adaptive cruise functionality of evaluated systems performed well, sometimes exceeding expectations. However, each test driver noted some degree of flawed performance during each drive of every test vehicle in terms of lane-keeping functionality. The specific nature of lane-keeping events were varied; common events are listed below:
